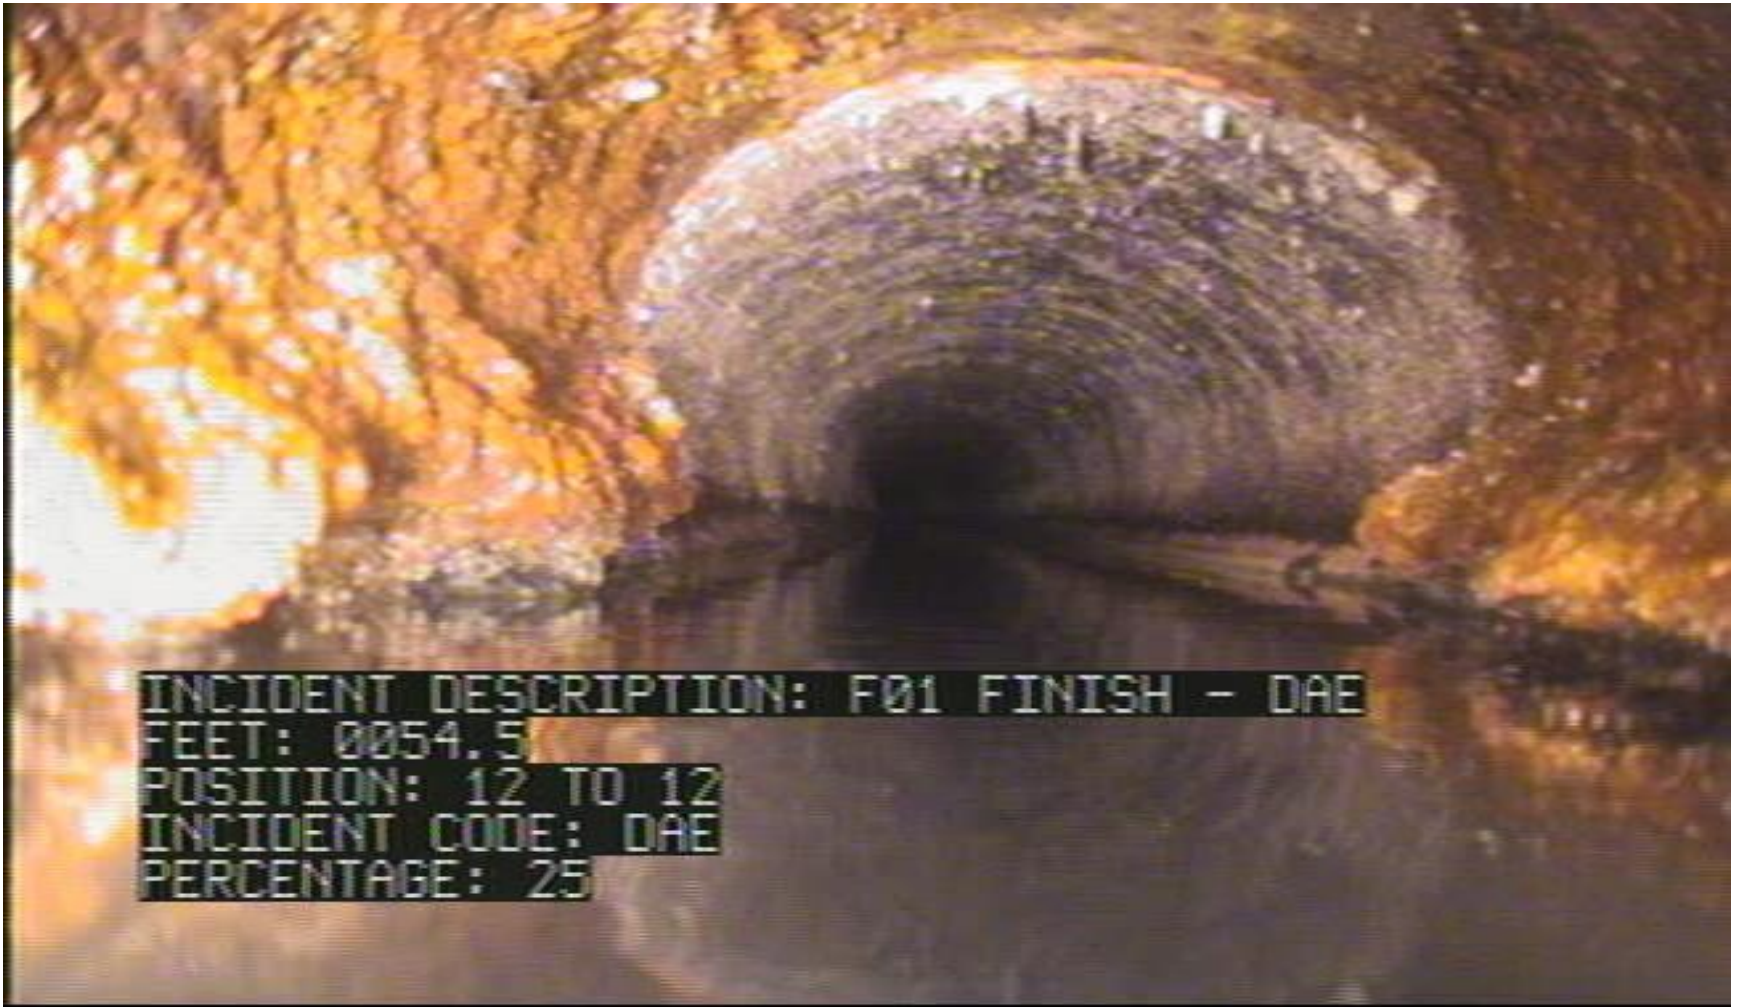
Transition CI to PVC

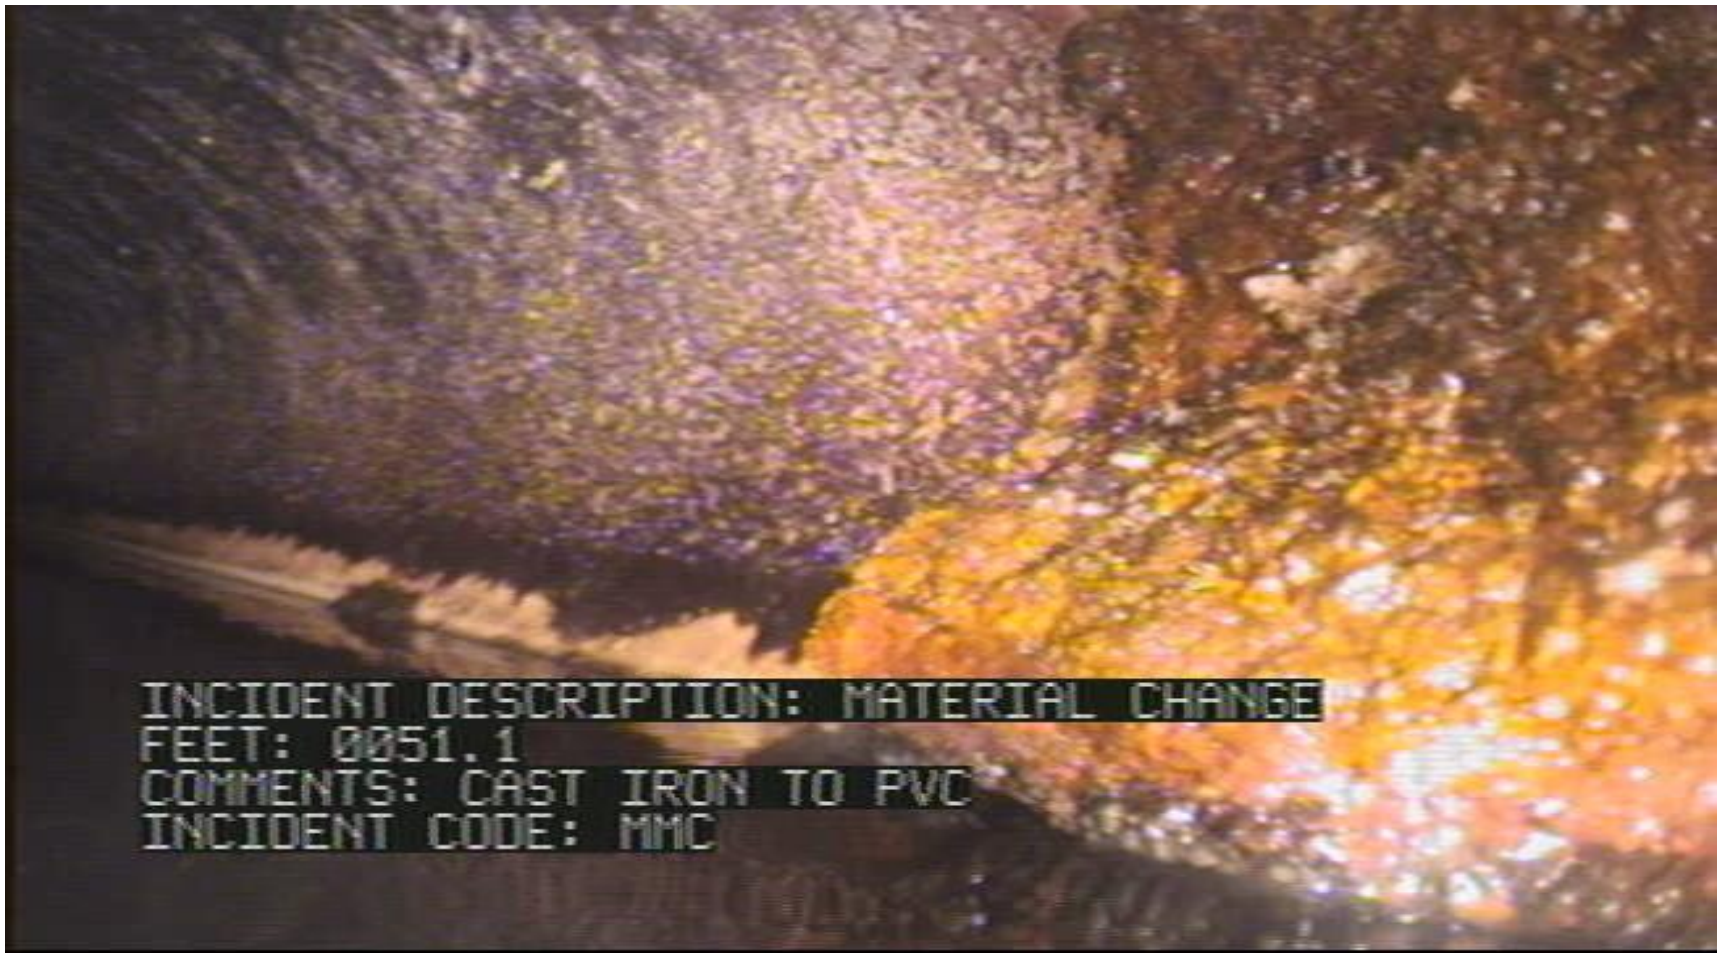
Close up CI to PVC

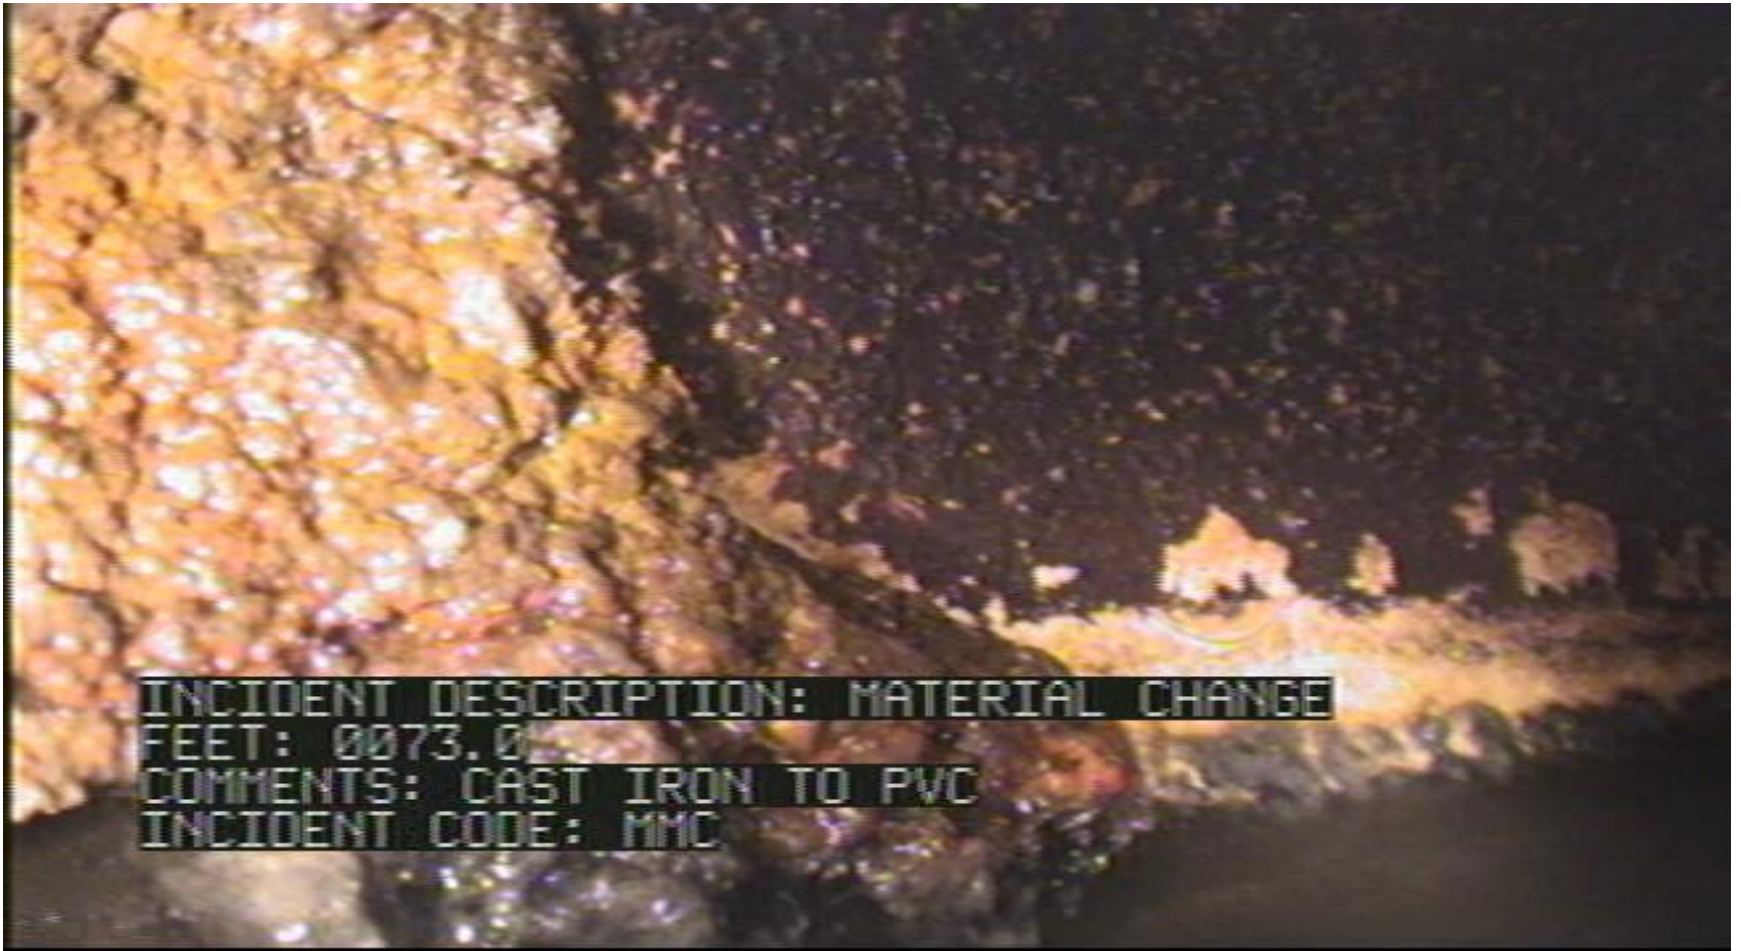
WO19-WO18 CI to PVC

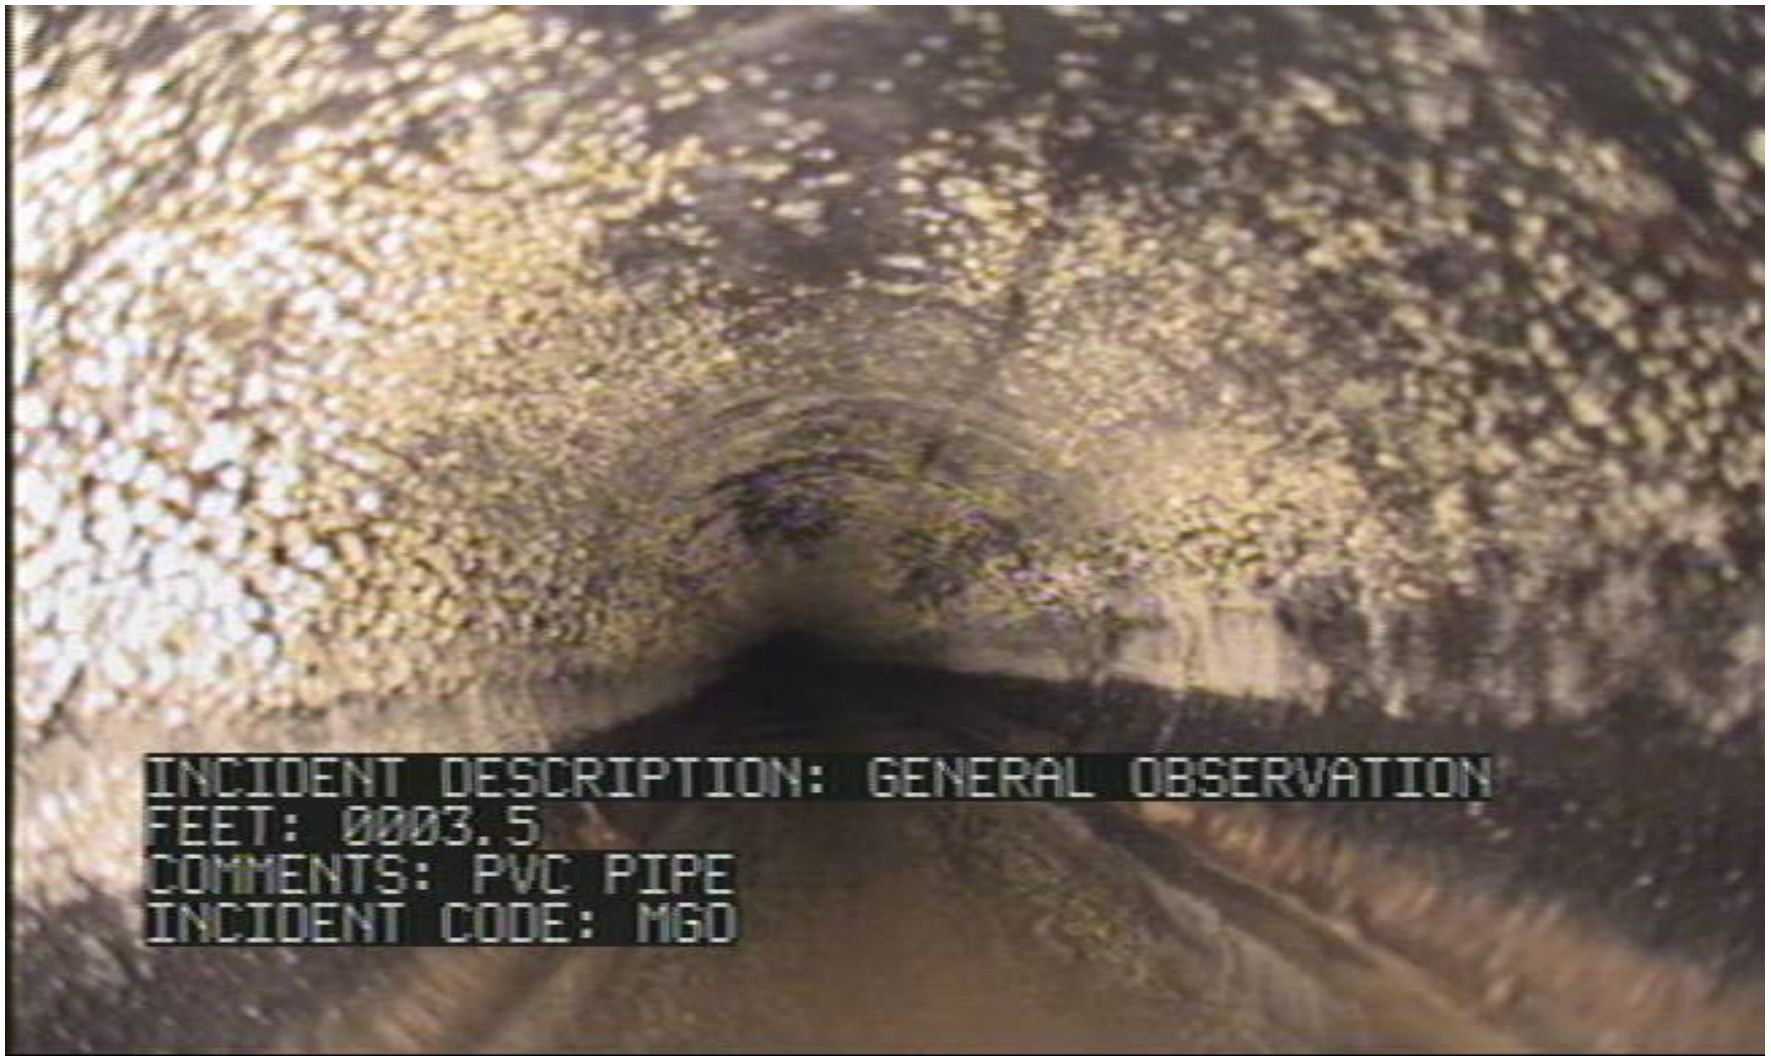
PVC tie-in to WO 21 from Steakhouse

INCIDENT DESCRIPTION: GENERAL OBSERVATION
FEET: 0003.5
COMMENTS: PVC PIPE
INCIDENT CODE: M60

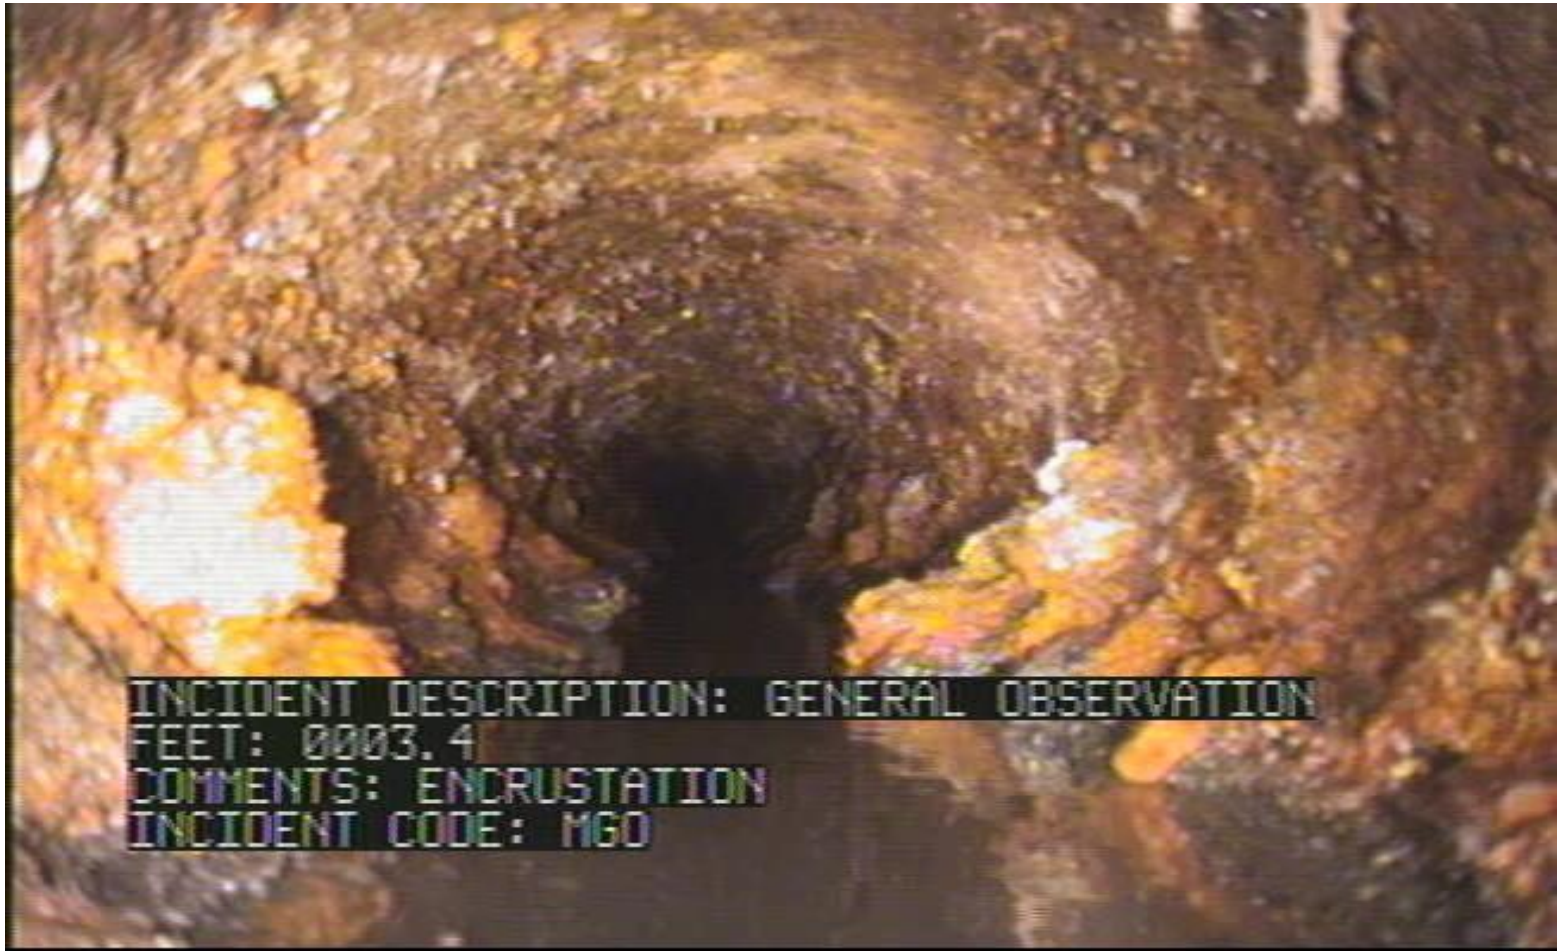
WO19 to WO20 Heavy Rust Encrustation

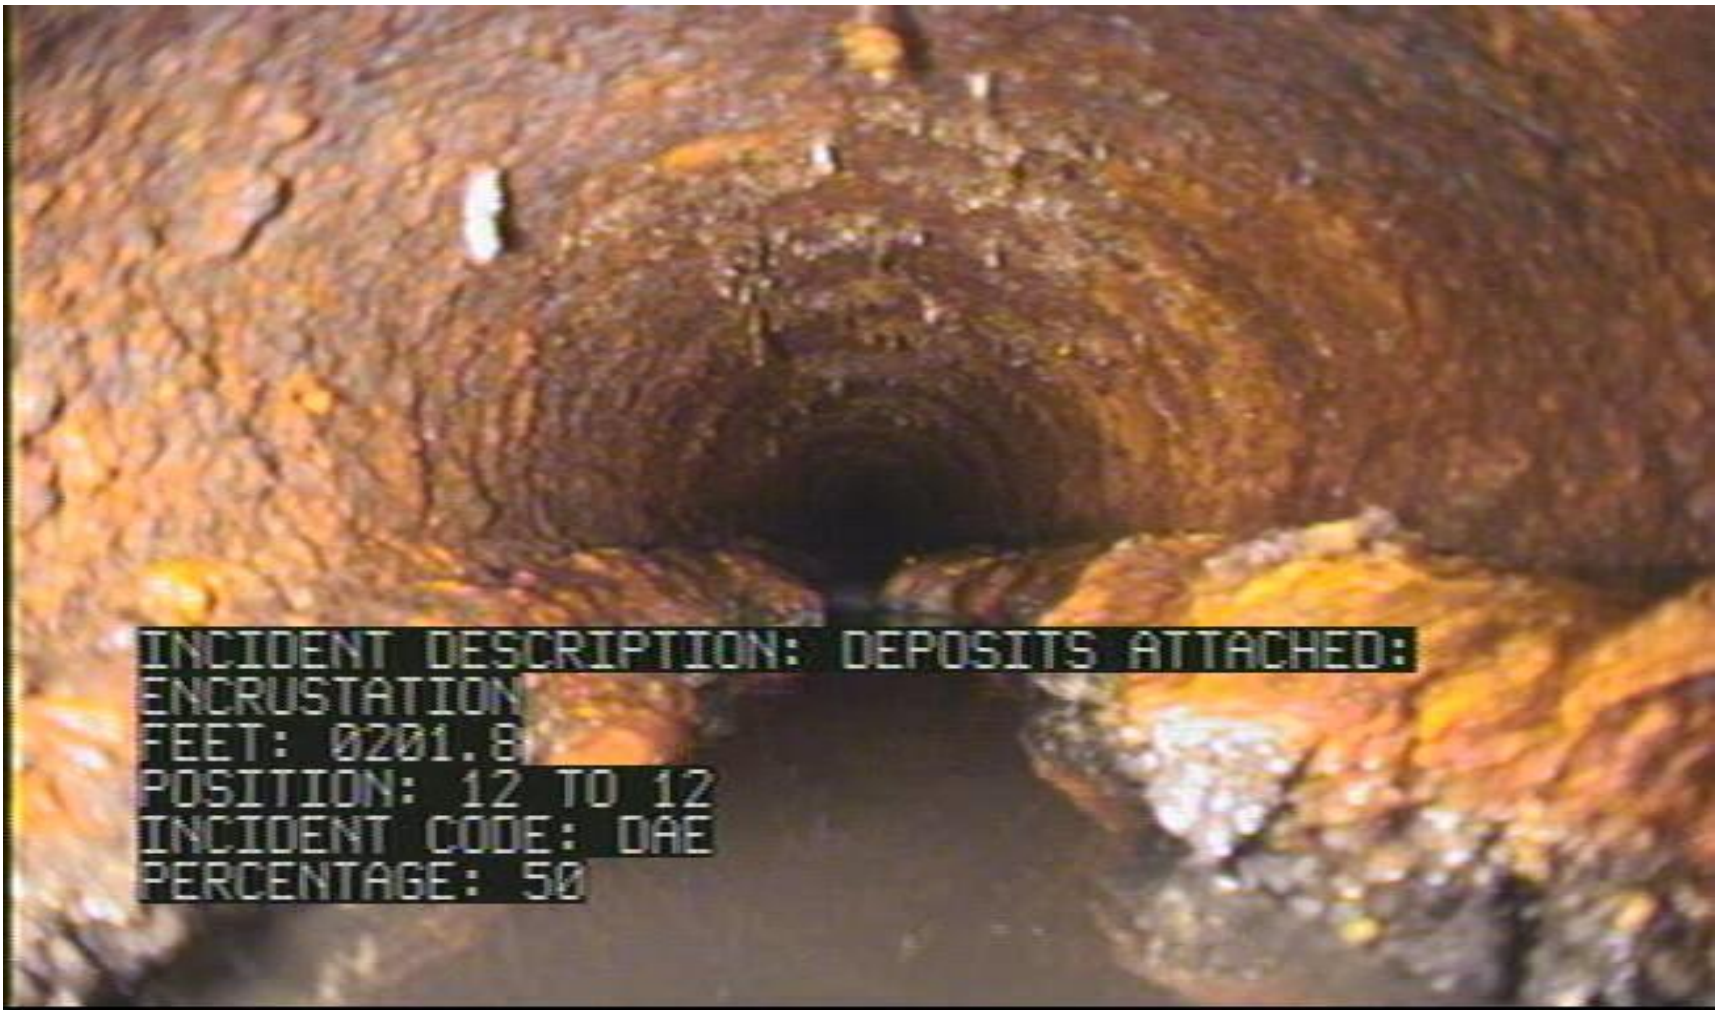
WO 20 to WO 19 Heavy Encrustation with flow channel

INCIDENT DESCRIPTION: DEPOSITS ATTACHED:
ENCrustATION
FEET: 0201.8
POSITION: 12 TO 12
INCIDENT CODE: OAE
PERCENTAGE: 50
