Advisian

30 April 2018

Proj. No.: 308010-00159

Re: Sanitary Outfall Assessment for the Town of Discovery Bay

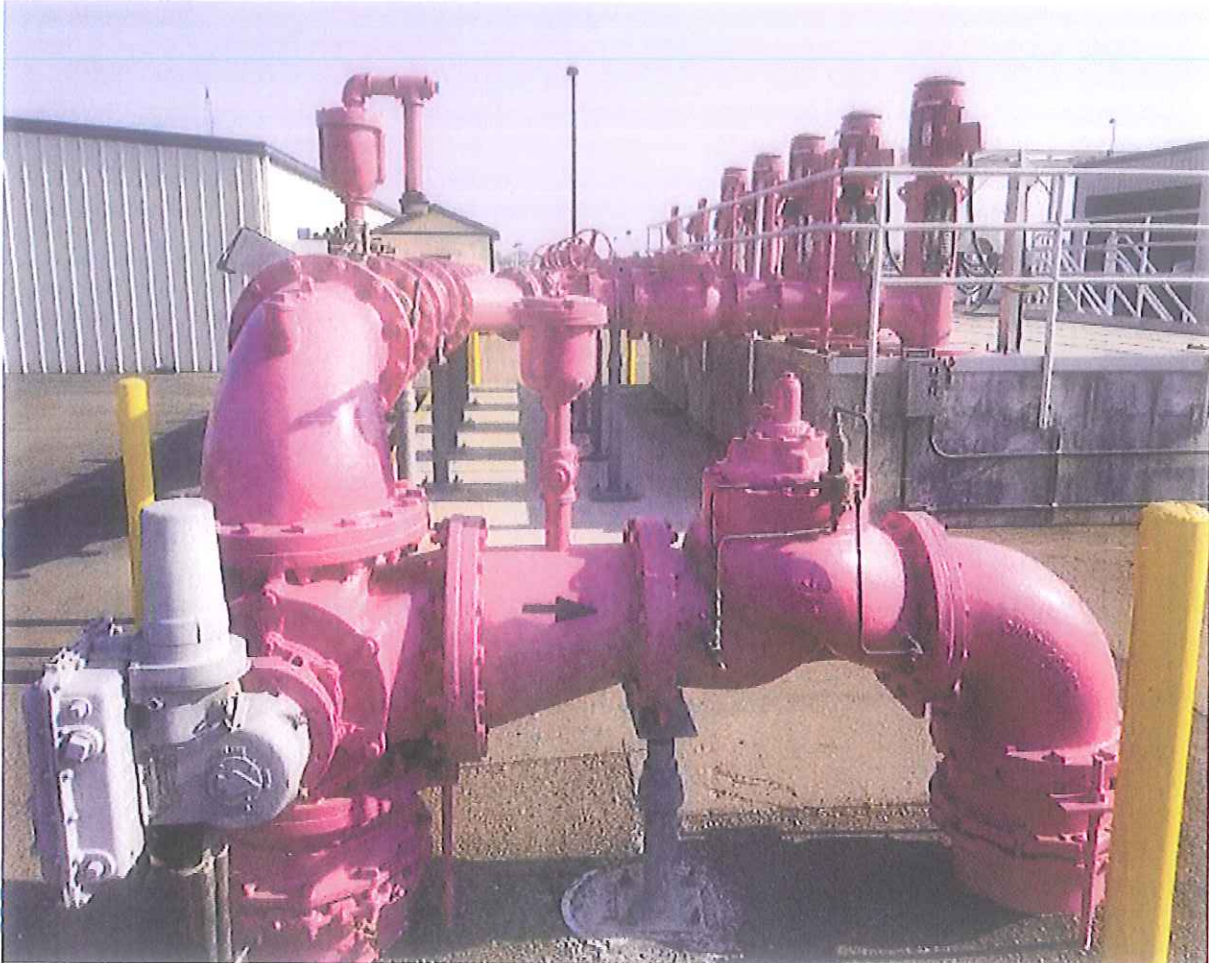
Also, as part of the site visit, a pump test was completed for all of the five vertical turbine pumps (Photo B) at the wastewater treatment plant. The test procedure was to allow the lift station sump to fill to its volume capacity and then activate the pumps to its maximum flow. Recordings were made for approximately 5 to 10 minutes obtaining reading from the flow meter and pressure head for the pump gauges. It is important to note that one of the pump gauges (first pump from north to south) was not operating, so reading were obtained for 4 out of the 5 lift station pumps. The result of the pump test indicated an average flow of 3.11 MGD for an approximate pumping head of 20 psi gauge (psig).

Photo B Discovery Bay Community Service District Sewage Treatment Plant Export Pump Station

- Based on the results of this assessment, the following recommendations were made:
- To verify that there are no significant issues with the performance of the Lift Station (5 pumps), it is recommended to complete a pumping test using the lift station recirculation system. The result of this pump test should be then compared to the original performance result of the system to confirm no loss in original pumping performance.

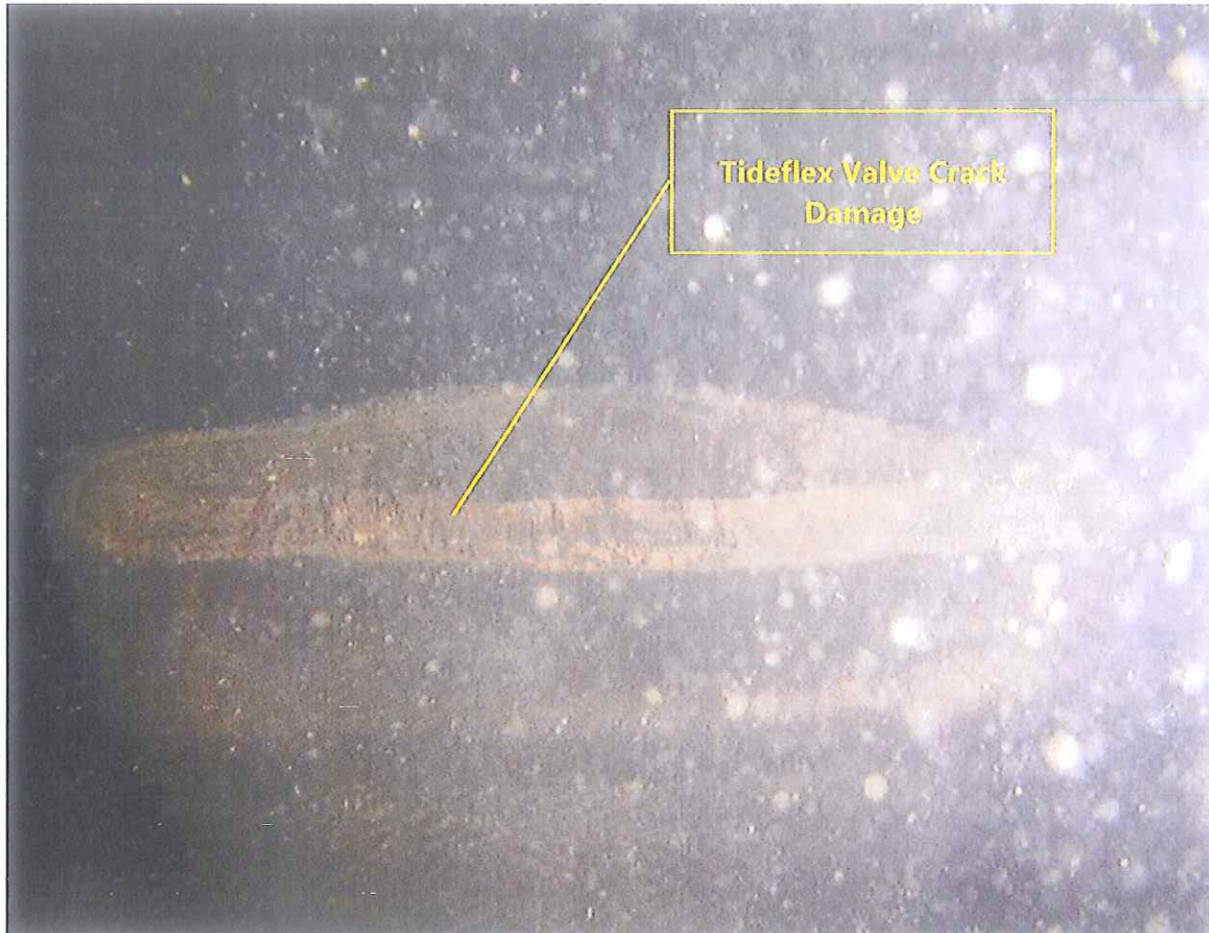
On December 2, 2017, Bishop Diving & Salvage completed an updated underwater survey of the outfall including 123 ft. of HDPE pipe (comprised of 18 in., 10 in. and 6 in. pipeline segments). The inspection showed similar outcomes to the 2013 survey, with 2 out of the 36 ports missing and no flow observed in the 6 in pipeline segment (16.5 ft. long). Also some of the Tideflex valves appeared to have cracks and may not be sealing properly, therefore allowing for outside sediments into the diffuser (see Photo C). These results confirmed the observations of the CCTV camera inspection, which inferred a partial blockage at the downstream end of the 10 in. segment (weak flow out of port 28) and a complete blockage of the 6 in. segment (with no flow observed out of port 31-36).

Photo C **Discovery Bay Outfall Diffuser - Tideflex Valve Showing Crack Damage at its Opening**

TDBC indicated that some of the tideflex riser pipes are being broken off or damaged. The damage may be attributable to recreational fishing boats that drop anchor near the diffuser to fish. Anchor lines may be snagging the tideflex risers and since the riser pipes contain a break-off groove, the risers are easily lost. A more likely culprit is the large amount of submerged debris moving through the Old River which collide with the risers and break them off during periods of high flows. The debris flow contains logs, lumber, steel propane tanks, pieces of shipwrecks, as well as mats of semi-submerged vegetation, which easily snag the riser pipes and break them off. Consider relocating the outlet ports along the springline of the diffuser pipe instead of along the top of pipe. The tideflex valves could be installed on the ends of lateral pipes extending away from the diffuser body and containing an upturned elbow to allow the tideflex leaf to operate with the tide as intended. The tideflex valves will then sit lower in the water, be less vulnerable to debris damage, and be partially protected by the diffuser pipe itself. Also, installing the lateral extension pipes increases the distance between neighboring tideflex valves, which may enhance the dilution capabilities of the system.

- It is recommended that for all design options a protection (cage is installed) be considered to prevent damage from boating activities (e.g. vessel anchors).

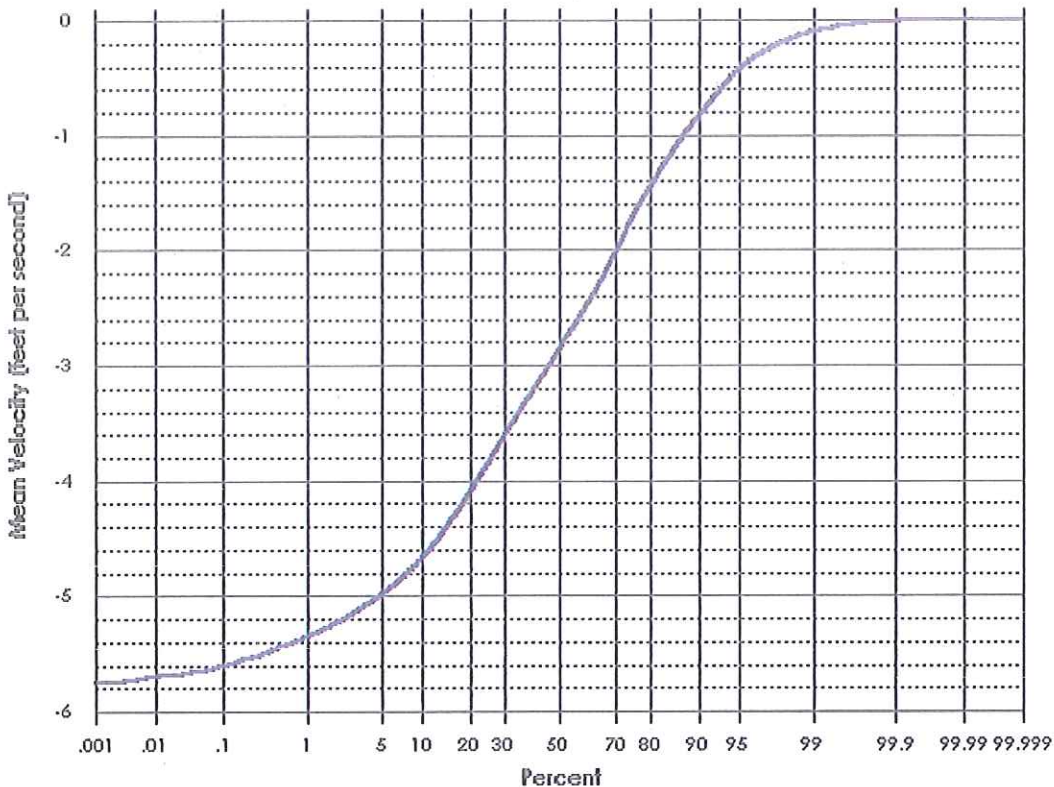
Per the Komex report (Komex 2004b), The United States Geological Service (USGS) river flow data for the Old River at the Highway 4 Bridge was analyzed to determine the probability distribution of the mean velocity in the river channel. Due to limitations in how much data could be analyzed at that time (65,536 rows); the probability distribution is based upon data collected from October 13, 2001 through September 22, 2003 (data collected at 15-minute intervals). As the Old River is strongly tidal, the data were analyzed for the direction that had the highest mean velocities (the "negative" velocity direction towards the south meaning tidal inflow). Based upon an analysis of that data, the probability distribution of mean river velocity is presented in Figure A.

Figure A Old River at Highway 4 Bridge – Probability Distribution of Mean Velocity

The probability distribution of mean river velocity indicates that scour is an important criterion that must be considered in the riverbed diffuser support design. Therefore, it is recommended that for Options 1, 2 and 4 the diffuser be placed in an excavated trench below the depth of scour, approximately 2.5 feet below the existing riverbed, and for all four options, an articulated concrete block matt (ACBM) should be installed above the header at the level of the existing bed to prevent scour in the region of the diffuser. Since the ACBM is porous, it would be important to incorporate a geotextile into the design to prevent bed material loss through the interstitial spaces.

- The probability distribution of mean river velocity indicates that scour is an important criterion that must be considered in the riverbed diffuser support design. Therefore, it is recommended that for Options 1, 2, and 4 the diffuser be placed in an excavated trench below the depth of scour, approximately 2.5 feet below the existing riverbed, and for all four options, an articulated concrete block matt (ACBM) should be installed above the header at the level of the existing bed to prevent scour in the region of the diffuser. Since the ACBM is porous, it would be important to incorporate a geotextile into the design to prevent bed material loss through the interstitial spaces.
