14 March 2018

RE: SANITARY OUTFALL ASSESSMENT FOR THE TOWN OF DISCOVERY BAY

1. INTRODUCTION

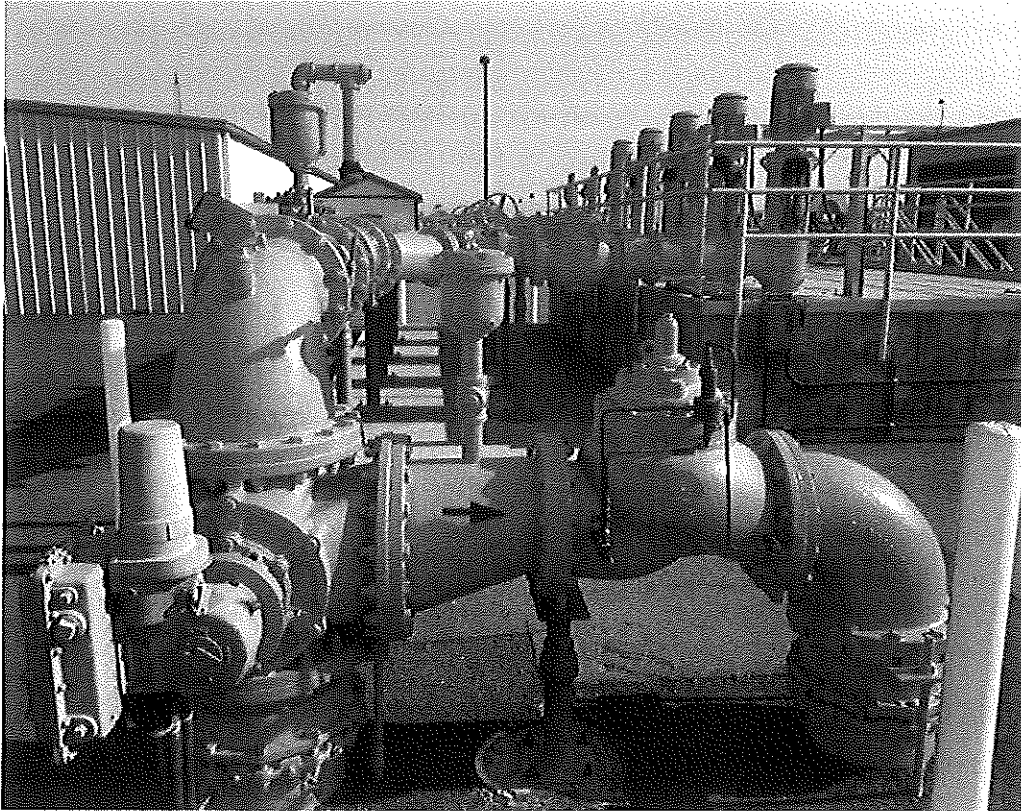
Also, as part of the site visit, a pump test was completed for all of the five vertical turbine pumps (Photo 2) at the wastewater treatment plant. The test procedure was to allow the lift station sump to fill to its volume capacity and then activate the pumps to its maximum flow. Recording were made for approximately for 5 to 10 mins obtaining reading from the flow meter and pressure head for the pump gauges. It is important to note that one of pump gauges was not operating, so reading were obtained for 4 out of the 5 lift station pumps. The result of the pump test indicated an average flow of 3.11 MGD for an approximate pumping head of 20 psig.

Photo 2 Discovery Bay Community Service District Sewage Treatment Plant Export Pump Station

- To verify that there are no significant issues with the performance of the Lift Station (5 pumps), it is recommended to complete a pumping test using the lift station recirculation system. The result of this pump test should be then compared to the original performance result of the system to confirm no loss in original pumping performance.

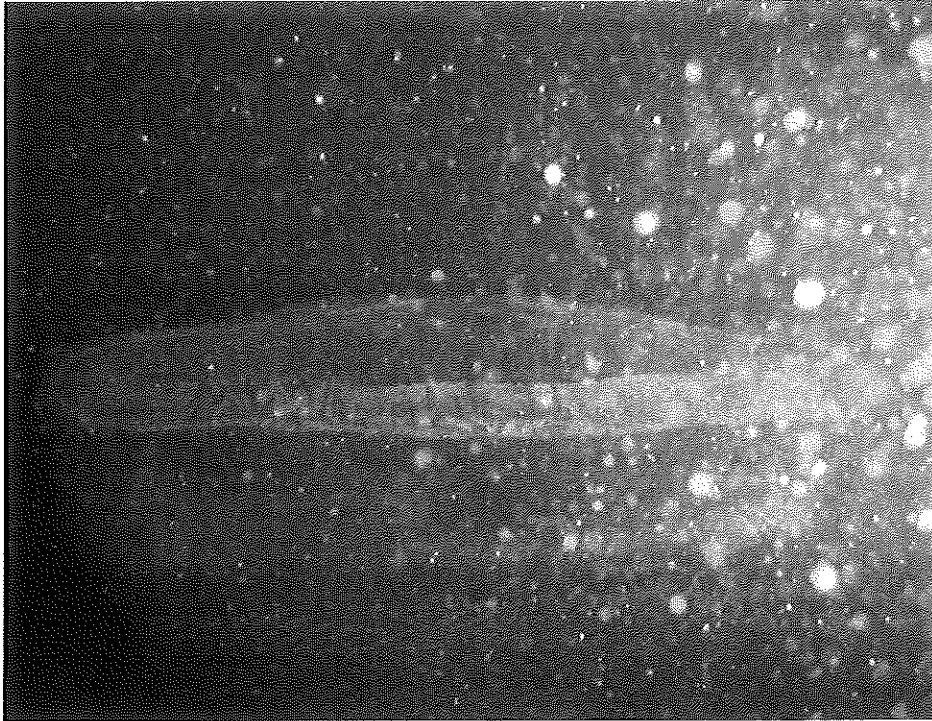
On December 2, 2017, Bishop Diving & Salvage completed an updated underwater survey of the outfall including 123 ft. of HDPE pipe (comprised of 18 in., 10 in. and 6 in. pipeline segments). The inspection showed similar outcomes to the 2013 survey, with 2 out of the 36 ports missing and no flow observed in the 6 in pipeline segment (16.5 ft. long). Also some of the Tideflex valves appeared to have cracks and may not be sealing properly, therefore allowing for outside sediments into the diffuser (see Photo 3). These results confirmed the observations of the CCTV camera inspection, which inferred a partial blockage at the downstream end of the 10 in. segment (weak flow out of port 28) and a complete blockage of the 6 in. segment (with no flow observed out of port 31-36).

Photo 3 Discovery Bay Outfall Diffuser - Tideflex Valve Showing Crack Damage at its Opening

- Out of the three repair/upgrades presented in this document, Advisian recommends Option 3, as it will require less disturbance of the outfall area and may require an easier installation. This option will also use reduced number of ports, which will reduce maintenance and lower the chances of obstruction damage. In addition, this option will involve shorter ports compared to the original design therefore, allowing for sufficient water depth above it without restricting boating activities in the river.

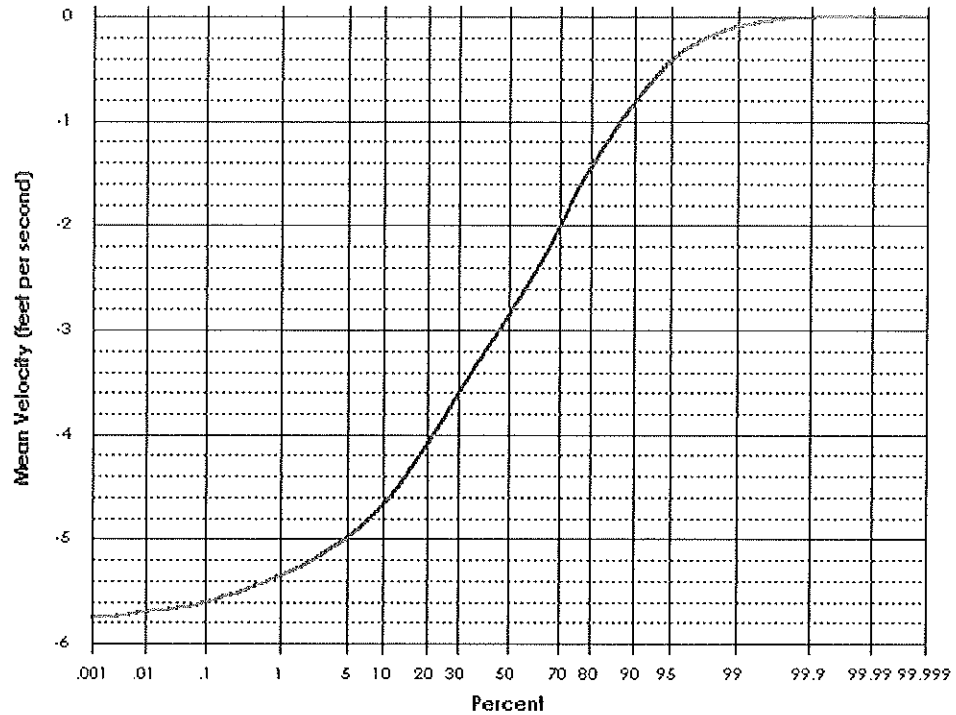
Figure 1 Old River At Highway 4 Bridge – Probability Distribution of Mean Velocity

The probability distribution of mean river velocity indicates that scour is an important criterion that must be considered in the riverbed diffuser support design. Therefore, it is recommended that for Options 1, and 2 the diffuser be placed in an excavated trench below the depth of scour, approximately 2.5 feet below the existing riverbed, and for all three options, an articulated concrete block matt (ACBM) should be installed above the header at the level of the existing bed to prevent scour in the region of the diffuser. Since the ACBM is porous, it would be important to incorporate a geotextile into the design to prevent bed material loss through the interstitial spaces.

- The probability distribution of mean river velocity indicates that scour is an important criterion that must be considered in the riverbed diffuser support design. Therefore, it is recommended that for Options 1, and 2 the diffuser be placed in an excavated trench below the depth of scour, approximately 2.5 feet below the existing riverbed, and for all three options, an articulated concrete block matt (ACBM) should be installed above the header at the level of the existing bed to prevent scour in the region of the diffuser. Since the ACBM is porous, it would be important to incorporate a geotextile into the design to prevent bed material loss through the interstitial spaces.
